Evaluation Report 134

Massey Ferguson Model 128 Baler

MASSEY FERGUSON MODEL 128 BALER

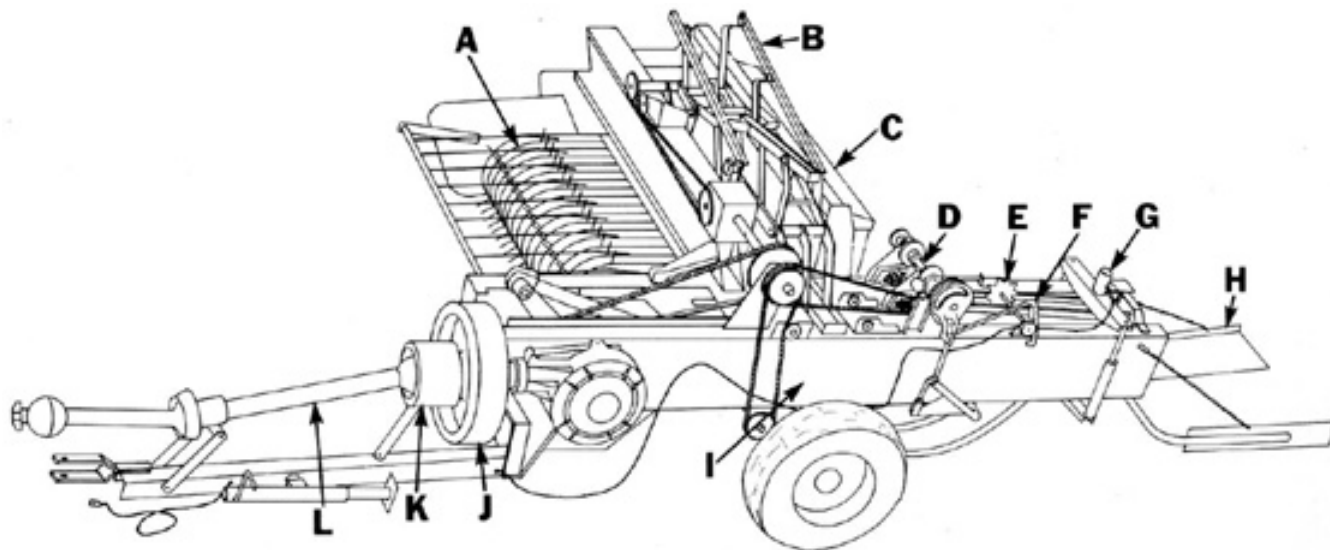
FIGURE 1. Massey Ferguson 128 Baler: (A) Pickup, (B) Packer Fork, (C) Twine Box, (D) Knotter, (E) Metering Wheel, (F) Metering Arm, (G) Hydraulic Bale Density Ram, (H) Bale Chute, (I) Bale Chamber, (J) Flywheel, (K) Slip Clutch, (L) Power Shaft.

FIGURE 1 shows the location of major components while detailed specifications are given in APPENDIX I.

Feeding System: The packer fork (FIGURE 1) had three settings which were adequate to produce square, well formed bales in all crops. The packer fork was conveniently adjusted by hand.

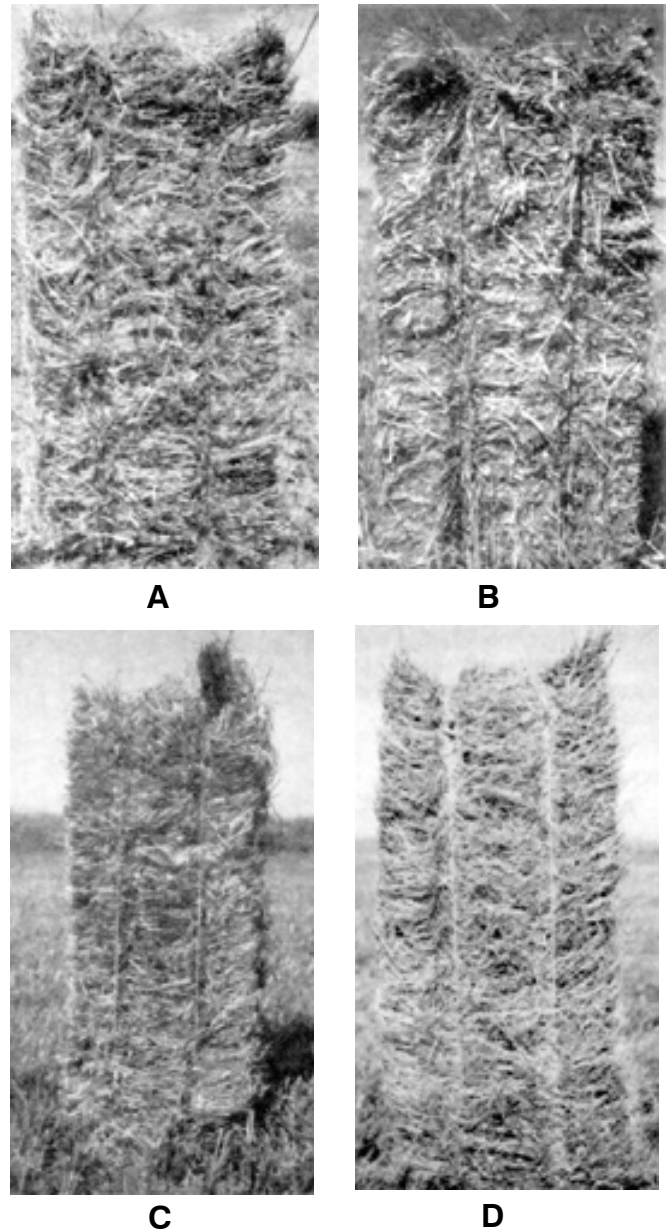
Bale Quality: The Massey Ferguson 128 was capable of producing firm, durable bales, with square ends, in all crops (FIGURE 2). Average hay bales weighed 28 to 32 kg while average straw bales weighed 20 to 22 kg. Average bale density varied from 191 kg/m³ in heavy alfalfa to 113 kg/m³ in light straw.

FIGURE 2. Typical Bales: (A) Alfalfa, (B) Straw, (C) Green Feed, (D) Crested Wheatgrass.

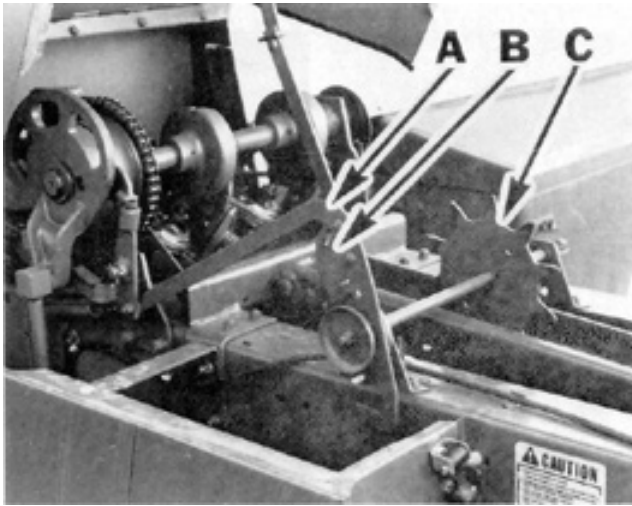
Bale length is adjusted by positioning the metering arm stop (FIGURE 3). The metering wheel advances the metering arm with each plunger stroke. Bale length uniformity depends on a consistent number of plunger strokes to form each bale. If the metering arm trips at the beginning of the last plunger stroke, rather than at the end of the stroke, bale length is increased by the length of compressed hay delivered during the last plunger stroke. Uniform feedrates are therefore important in reducing bale length variation.

FIGURE 3. Bale Length Adjustment: (A) Metering Arm, (B) Adjustable Stop, (C) Metering Wheel.

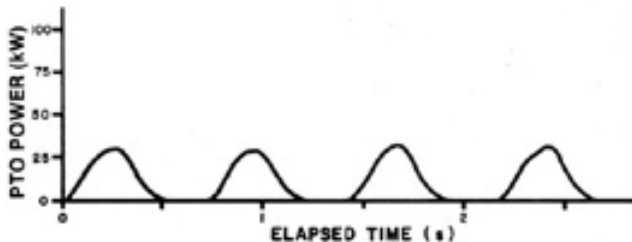
Power Take-Off Requirements: FIGURE 4 shows typical instantaneous power take-off requirements for the Massey Ferguson 128. Power requirements fluctuated from 0 to 26 kW on each plunger stroke. Due to these wide power fluctuations, average power requirements were less than instantaneous requirements, varying from 5 to 21 kW, over a full range of feedrates. FIGURE 5 shows the average power take-off requirements at various feedrates in alfalfa and wheat straw.

FIGURE 4. Instantaneous Power Take-off Requirements when Baling Alfalfa at 10 t/h Feedrate.

Tractor Size: The manufacturer recommended a minimum tractor size of 22 kW. Average power take-off requirements were usually less than 21 kW and power required to pull the baler on level ground was usually less than 5 kW. A 40 kW tractor was, however, needed to fully utilize baler capacity in soft or hilly fields and to overcome the power fluctuations illustrated in FIGURE 4.

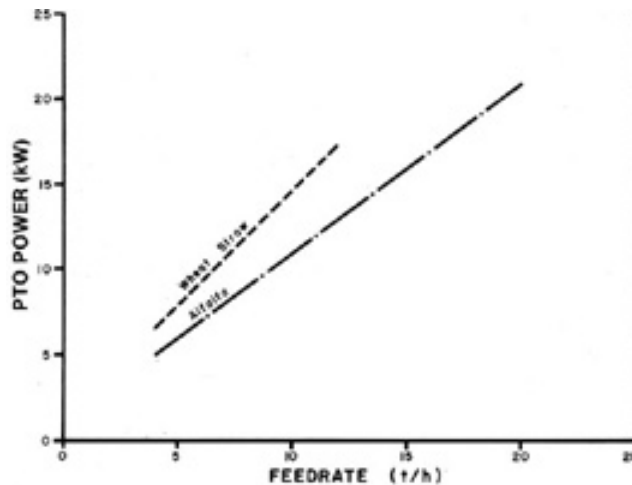
FIGURE 5. Average Power Take-off Requirements when Baling Alfalfa and Straw.

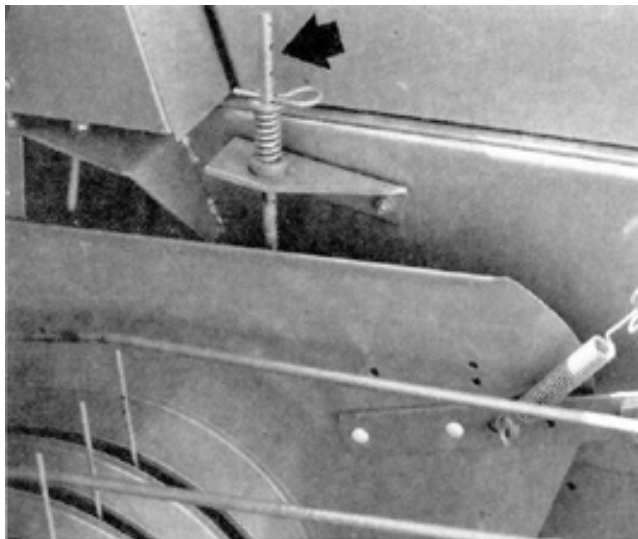
Pickup: Pickup height was easily adjusted without tools (FIGURE 6). A wrench was needed to position the pickup gauge wheel.

FIGURE 6. Pickup Height Adjustment.

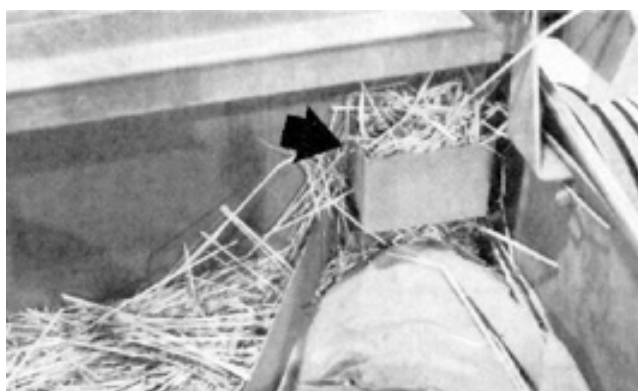
Tool Box: A box located in the twine box was provided for storing small tools and spare shear bolts. The box was of limited use since it quickly filled with hay (FIGURE 7), making small pieces difficult to find.

FIGURE 7. Tool Box Filled With Hay.

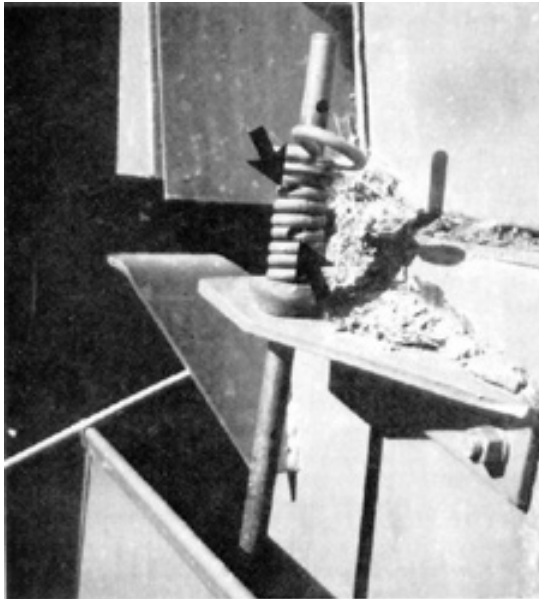
- The pickup gauge spring broke at	104	16,830
Knottter Assembly		
- The bale counter trip arm jammed, breaking the counter. The counter was replaced at	5	810

Pickup Gauge Spring: The spring on the pickup gauge spring broke in two places, due to fatigue, after 104 hours of use (FIGURE 8).

FIGURE 8. Broken Pickup Gauge Spring.

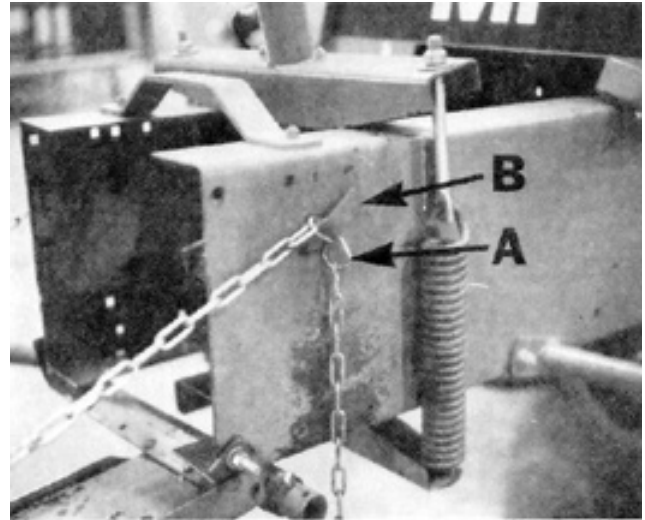
- Sharp edges on the bale chute were cutting the twine as bales were ejected. The edges were filed smooth at	7	1130
- The bale chute chain had stretched and was replaced at	60	9710

- The right bale chute hook broke and was rewelded at	62	10,030
- The bale chute bent and was straightened at	70,86	11,330, 13,920
- The left bale chute hinge bolt sheared while operating on rough ground and was replaced at	79, 61	12,790, 13,110

Chain and Hook: The bale chute chains deformed (FIGURE 9) and the right bale chute hook failed at the weld. The chain was replaced and the hook rewelded.

FIGURE 9. Bale Chute Chain Assembly: (A) Deformed Chain, (B) Bale Chute Hook.

1. Specifying lubrication requirements for the plunger wrist pin bushing and packer fork crank bearing.
2. Repositioning the hitch jack to eliminate possible interference with the rear tractor tire on left turns.
3. Modifications to prevent the outer pickup tension spring eyebolt nut from loosening.
4. Modifications to prevent bale chute damage during transport.

Transporting Problems: Occasionally the chain on the left side of the bale chute loosened when transporting, allowing the bale chute to dig in the ground. It is recommended that the manufacturer consider modifications to prevent this occurrence.
